Is There a Threshold for PSB Formation in Iron

ABSTRACT

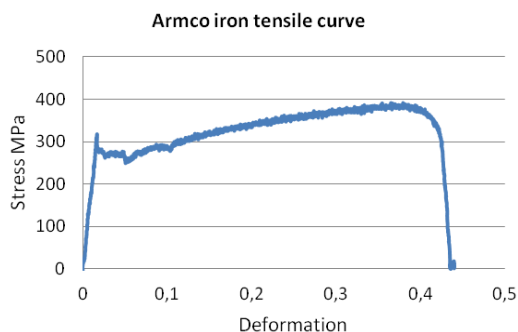
Fig 1. Stress-strain curve

The studied material is a polycrystalline α iron whose chemical composition is given in Table 1 and mechanical properties of corrected true stress-strain is given in Fig 1. The microstructure is ferrite with equiaxe grains. The ferrite grain size is included in 10 to 40 μm . No specifically orientation was observed by EBSD.

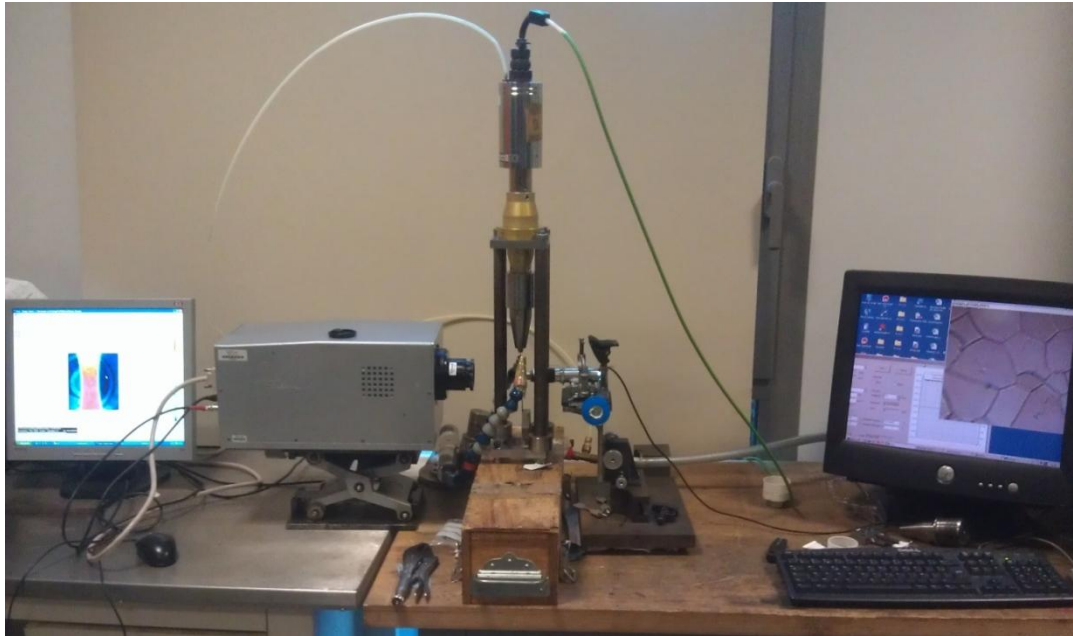
Fig. 3 Experimental system

According to specimen designs, the specimen center has zero axial displacement theoretically during ultrasonic fatigue loading. The displacement rises continually at positions both sides away from the center. There is a small area on the surface which includes specimen center remains visible by optical microscope because the displacement maintained at very low level. Therefore a mobile optical microscope constructed for taking the online image. It has magnification 320X and recording image at frequency up to 1 Hz. With this mobile optical microscope, it is possible to observe general appearance when character deformation takes place in the specimen surface like enforced slip bands. The typical online observation system is shown at Fig. 3.
