Study of fatigue crack mechanism on an armco iron in the gigacycle fatigue by temperature recording and microstructural observations

Abstract: Whatever the fatigue domain, the fatigue crack mechanism consists of an initiation crack stage (stage I) and a propagation stage (stage II). For materials without inclusions with a single phase, the first damage events in the stage I are due to the occurrence of Slips Marks (SM) on the specimen surface.

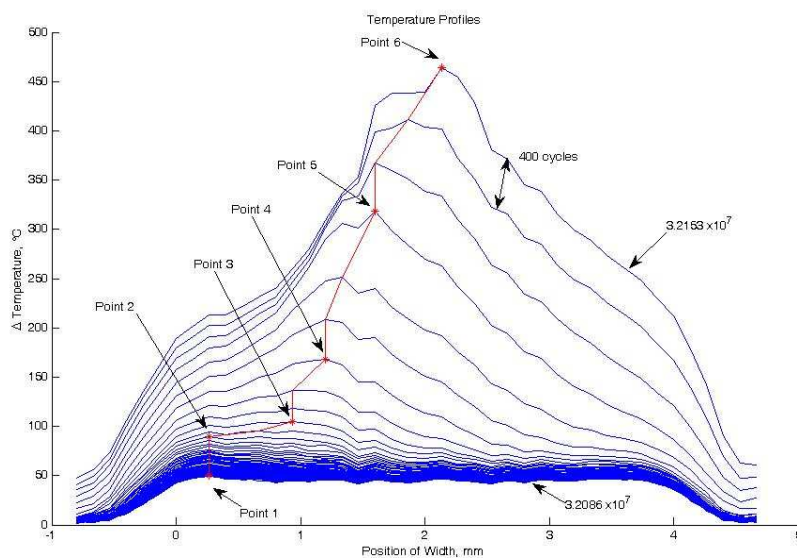
Figure 3 : Temperature profile along the specimen width

Between each profile, 400 cycles are performed. The red line on the figure 3 is the location where the temperature is maximum along the profile. Before 3.2086×10^7 cycles, it was not possible to determine a location where the temperature was maximum along the profile. For this test, the crack initiation site appeared on the left side of the specimen (on the left side of the figure 3). The locations of the points 1/2,3,4,5,6 where the maximum temperature rapidly increases were determined. From the specimen corner, the locations of the different points are : points 1 et 2 at $267 \mu\text{m}$, point 3 at $933 \mu\text{m}$, point 4 at $1200 \mu\text{m}$, point 5 at $1600 \mu\text{m}$, point 6 at $2000 \mu\text{m}$. The corresponding numbers of cycles are : N_1 (point 1) at 3.2086×10^7 cycles, N_2 (point 2) at 3.2148×10^7 cycles, N_3 (point 3) at 3.2149×10^7 cycles, N_4 (point 4) at 3.2151×10^7 cycles, N_5 (point 5) at 3.2152×10^7 cycles, N_6 (point 6) at 3.2153×10^7 cycles and the number of cycles at fracture N_f to 3.2155×10^7 cycles.

From these data, the temperature profile (Figure 3) along the specimen width was extracted for the 168 latest pictures captured by the camera, that is to say from $3.2086 \cdot 10^7$ cycles to $3.2153 \cdot 10^7$ cycles (number of the cycles at the failure).

During the end of this test, the maximum temperature location moves from the left to the right of the specimen width in agreement with the increase of the fatigue crack length and the increase of the plastic zone ahead the fatigue crack tip.

- At the number of cycles $N = 3.2086 \times 10^7$, the temperature profile on the specimen width shows a point (point 1, figure 3 and 7a) with a higher temperature. At this number of cycles, there is a rapid coalescence of PSB on specimen surface. Probably, the microcrack (due to the PSB) is also opened on the surface thickness of the specimen (point 1bis, figure 7a), and then, there is a coalescence between microcracks on the two surfaces (width and thickness). These points (1 and 1bis) correspond to the transition between crack initiation stage and short crack propagation stage (figure 6b). On the figure 7a, according to the all SEM observations (not presented here), this transition on the fracture surface has been reported. From the point 1, the temperature maximum increases, but this point does not move on the specimen width. This due to the formation of the crack initiation area between point 1 and 1bis. When the crack spreads from point 1 to point 1bis, the ΔK threshold is reached. The calculation according to the blue line is $4.1 \text{ MPa}\sqrt{\text{m}}$, which correspond to a plastic zone size of $\sim 47\mu\text{m}$. The number of cycles $N = 3.2086 \times 10^7$ is the number of cycles at the crack initiation N_i . This allows to calculate the ratio N_i/N_f equal to 0.9978. So, 99.8% of the total life is devoted to the initiation of the crack. As previously reported for the subsurface crack initiation in the gigacycle fatigue domain [4-5, 9-11], the major part of the total life is devoted to the crack initiation.

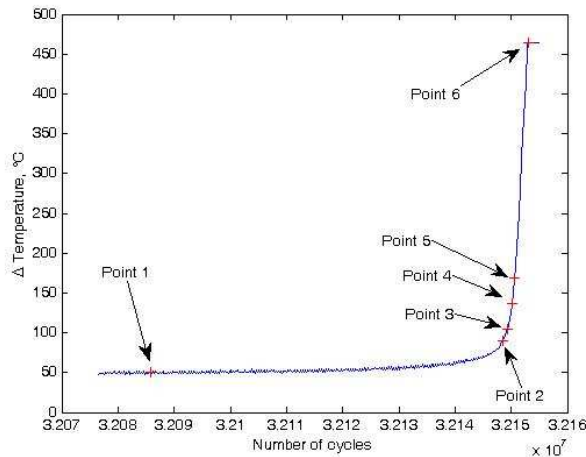
Figure 9: End of the temperature evolution versus number of cycles curve in relation with the number of cycles in each stage

From each point on the figure 3, the number of cycles can be calculated and reported on the curve

temperature versus number of cycles. Figure 9 is an enlargement of the end part of Figure 2, where the different points are reported. As previously published [5,9] for subsurface observations, the number of cycles of crack initiation N_i , corresponds to the weak temperature increase (point 1). The number of cycles between point 1 and 2 (Figure 9) corresponds to the crack initiation stage. Between point 2 and 3, the fast short crack propagation takes place. After the point 3, the plastic zone ahead the crack tip (figure 9) produces a great lot of PSB and then a great number of specific heat sources (PSB formation which are only visible on the specimen surface). The intrinsic dissipation d_1 and so the temperature grows rapidly until fracture.
