Fracture mechanisms during intergranular hold time fatigue crack growth in Inconel 718 superalloy.

Abstract Ni-base superalloy IN718 is known to display time-dependent intergranular crack growth under dwell time mechanical loading at high temperature under atmospheric conditions. Oxygen has been pointed out as a cause of the intergranular damage causing embrittled crack growth during both cyclic and hold time loading. Investigation of the mechanisms responsible for the embrittlement should not only focus on the effect of environment but also on the combined action of fatigue, creep, temperature and time. In this work material from experiments with fatigue crack growth in combination with hold times of different length at different temperatures has been investigated. Fractographic studies and metallographic cross sections of fatigued specimens has been subjected to careful analysis using ECCI- imaging in order to shed light on the fracture mechanisms. The results show that the damage is caused by the influence of a combination of environment and severe local damage manifested as a transformation of the microstructure into sub cells, micro twins and recrystallised areas close to the

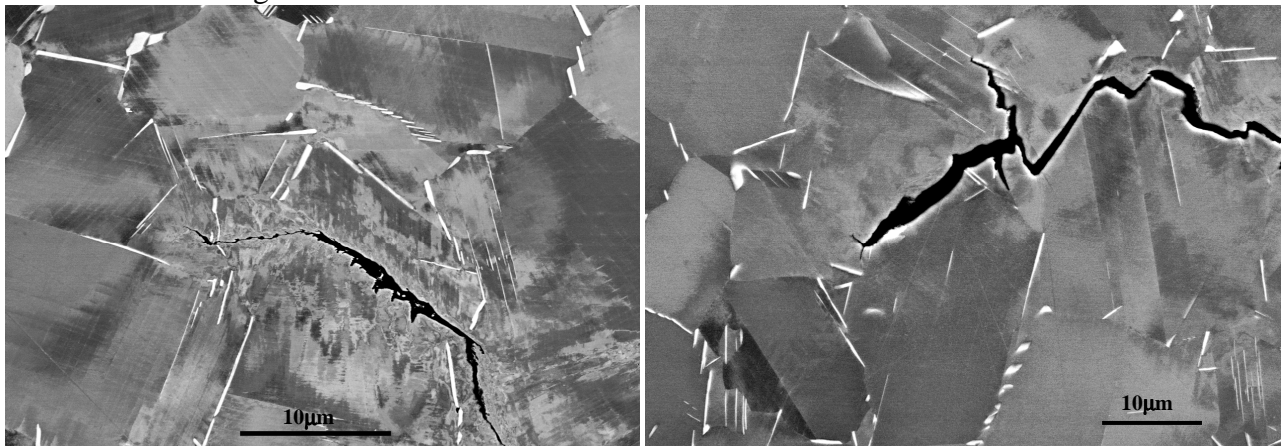
Figure 1. SEM-ECCI micrograph showing cross section of the crack tip region of IN718 subjected to base line fatigue at a) 450°C showing high slip activity and 650°C with lower slip activity.

In order to be able to distinguish between crack growth at different temperatures with and without dwell the results from crack growth without dwell will be presented first. In figure 1 the crack zone for baseline cracking at 450°C and 650°C is shown.

The lower temperature shows clear channeling contrast from plastic deformation caused by homogeneous slip on primary slip systems and in a narrow zone close to the crack localized more concentrated multiple slip. The crack path is transcrystalline with slight crack branching. The crack growth mechanism seems to be based on a weakening of interface at the crack tip by plastic deformation. For the higher temperature the crack path is more intergranular with more crack branching and the slip intensity is less pronounced.

The first one is the growth along grain boundaries where the mating grains are subjected to planar slip on one or two slip systems Figure 1a. The second growth mode is along grains with heavier homogeneous slip and a narrow zone close to the fracture surface with heavy non planar dislocation structure and sometimes twins and recrystallisation structure nicely shown in ECCI mode in the SEM Figure 3.

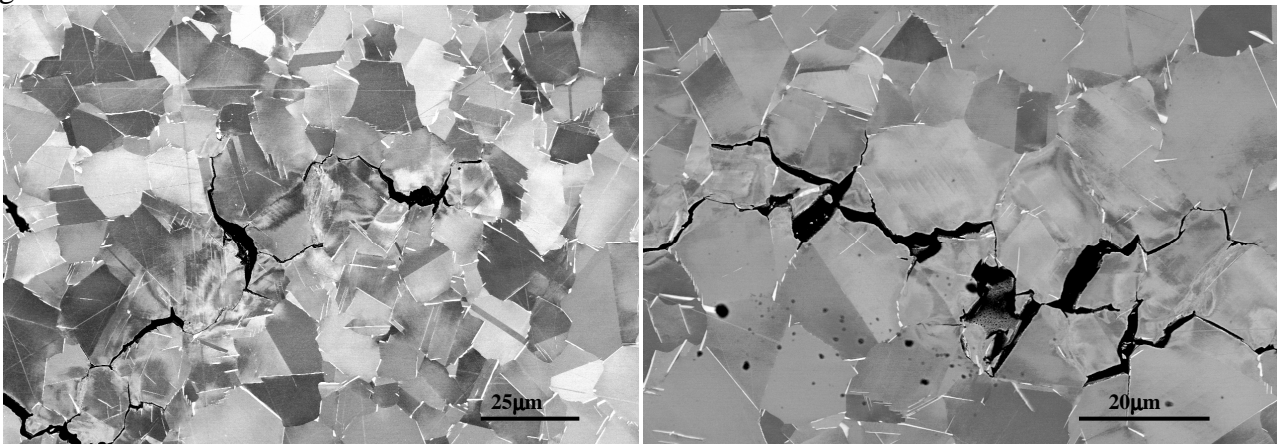
a b
Figure 2. SEM-ECCI micrographs showing cross sections of specimens with hold time at a) 550°C with intergranular branched cracks and clear signs of slip and b) 650°C with intergranular cracking and less pronounced plasticity.

The specimens subjected to dwell show more intergranular fracture and branching Figure 2 and the plastic deformation is more pronounced at 550°C but the fracture mode is varying along the crack

events caused by unloading between each hold time are difficult to distinguish along the crack front. The crack front seems to have the character of a spherical discontinuous process zone (fig.2) with branched intergranular cracks rather than a single crack moving through the microstructure. Crack growth could then consist of environmental oxygen induced intercrystalline growth of cracks along sensitized paths in different directions and an interlinking between embrittled areas showing ligaments with more severe slip. The ligaments are severely plastically deformed to a level that is very close to dynamic recrystallization with characteristic pores shown as black dots in Fig. 4b, Fig. 5 indicating a future crack path. The growth of the main crack is also influenced by interaction with δ -plates acting either as a crack path or as a crack stopper (fig 4a) depending on orientation. The fact that the δ -phase is ductile makes it less probable as a crack path but the interface between δ and matrix is often acting as a crack [10] path through severely oxidized pores in the interface as observed in this work. Non propagating branched cracks are stopped due to blunting and/or geometrical reasons like going into mode II. Residual stress built up during growth manifested by a closure of the crack along the front also plays a role for the path taken by the crack.

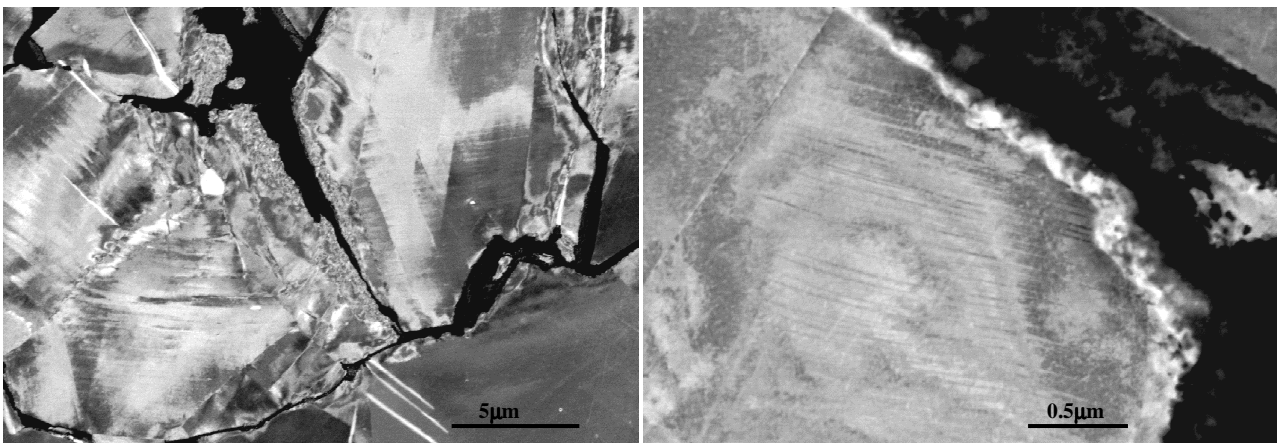
a) b)
Figure 3. SEM-ECCI micrographs showing a) the plastically damaged zone with sub grains and beginning recrystallisation close to the crack surface and b) deformation twins.

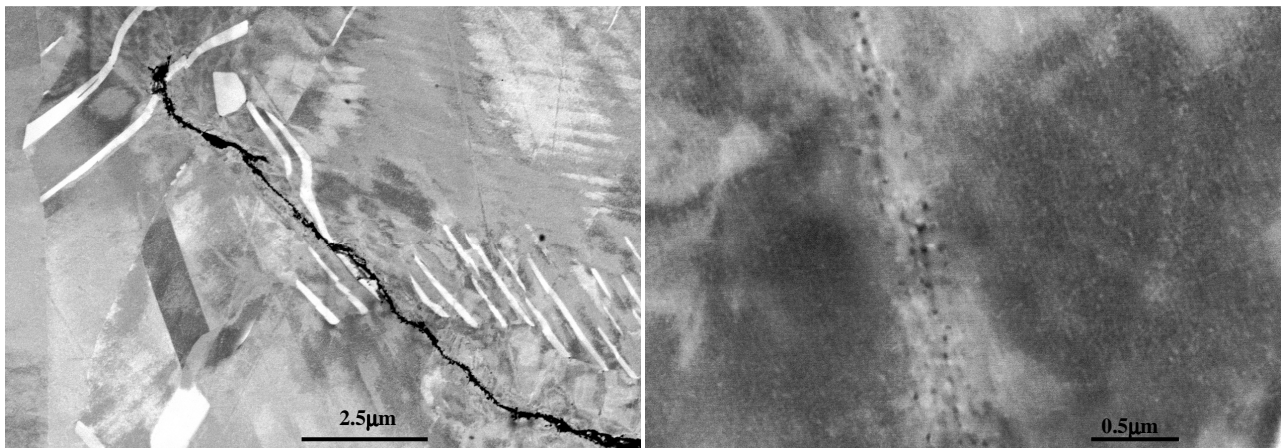
a b
Figure 4. SEM-ECCI micrograph showing a) the crack tip region and b) the damage zone in front of the crack tip at higher magnification with stringers of pores.

The third growth mode is cracking along δ -phase often oxidized into a sponge like structure in the interface between a δ -plate and the crack. It is thus difficult to say anything about the time-sequence of these events but the nanometric oxidized pores present at crack tips with a smallest size in the order of the hardening precipitates could trigger the onset of intercrystalline failure and the stress state and dislocation structure contributing factors Figure 4, 5, 6. The separate dwell time cracking

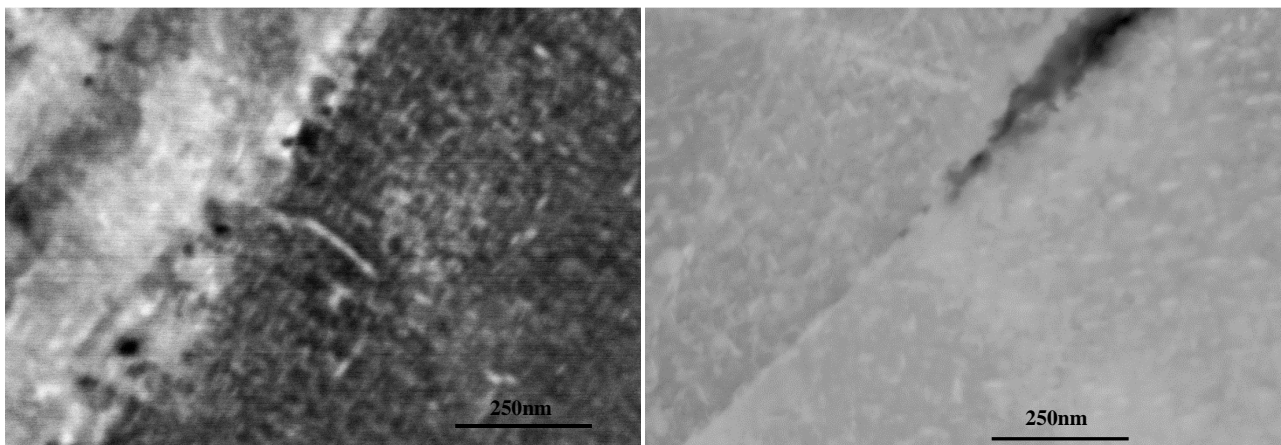
a b
Figure 5. SEM-ECCI picture of the damaged zone in IN718 at 550°C temperature close to the crack showing a) the hardening precipitates along with nano sized pores in an area with high plastic deformation and b) pores in a grain boundary with no plastic deformation.

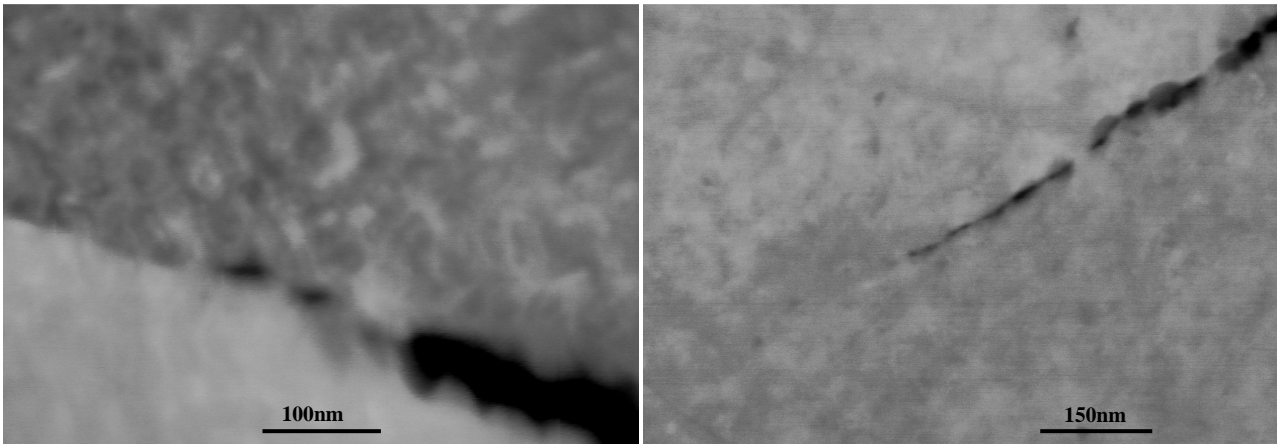
a b
Figure 6. SEM-ECCI micrographs of a) IN718 650°C during hold and b) ALVAC718plus 700°C during hold. Both alloys show voids in front of the crack tip. The smallest voids are in the same range of size as the hardening precipitates that are clearly visible in a).

The macroscopic crack path often shows a mismatch orthogonally indicating shear or grainboundary sliding along the crack growth direction. SEM ECCI pictures taken at a very high magnification of non propagating secondary cracks is shown in Fig. 6 where nanometric voids in the same size range as the clearly visible hardening precipitates Fig 6a are seen along the grain boundary. This type of voids is often seen along the crack front for longer cracks being coarser and more oxidized.

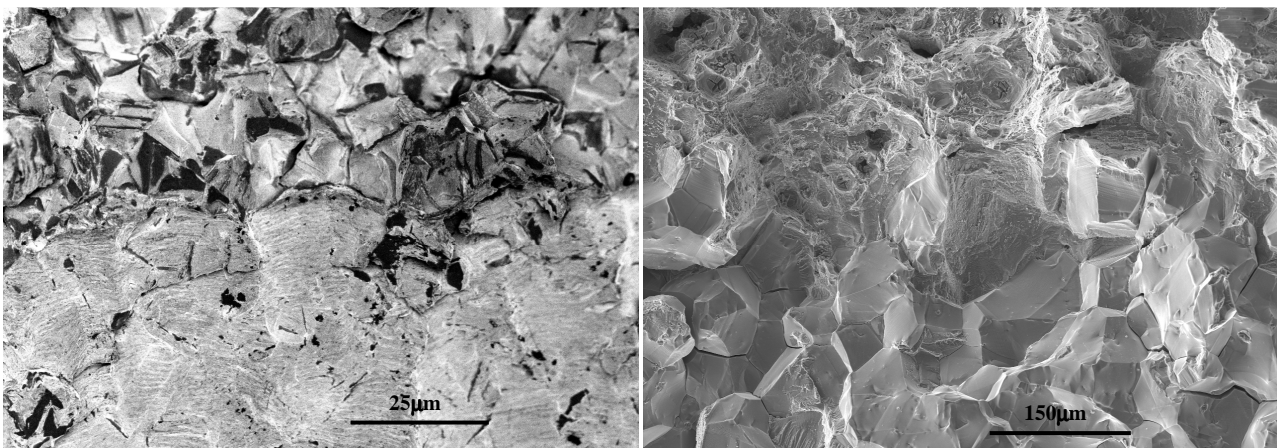
a b
Figure 7. SEM fractographs showing a) boundary between pre cracking at room temperature (lower) and dwell time growth at 550°C (upper), black contrast is δ -phase b) boundary between dwell cracking (lower) and final fracture (upper)in Allvac718plus at 700°C in pure oxygen atmosphere.

The dwell time cracking of Alvac718Plus in pure oxygen atmosphere shows (Fig. 7b) more clearly the intercrystalline character of the crack growth due to the absence of δ -plates (black in Fig. 7a) in this condition. The observable environmental action manifested by growth of oxidized pores in the grain boundaries seems to be the same as for IN718. The completely flat grain boundary surface has still slip bands and microscopic pores. The fatigue cycling in oxygen atmosphere at 700°C before the start of the dwell time cycle show clear striation like arrest markings indicating a continuous crack growth mode. Studying the fracture surfaces in higher magnification show signs of nano sized voids at the tip of branched cracks. The intergranular facets giving a smooth appearance at lower mag. (Fig 7b) show signs of voids at higher magnification (Figure 8, 9).

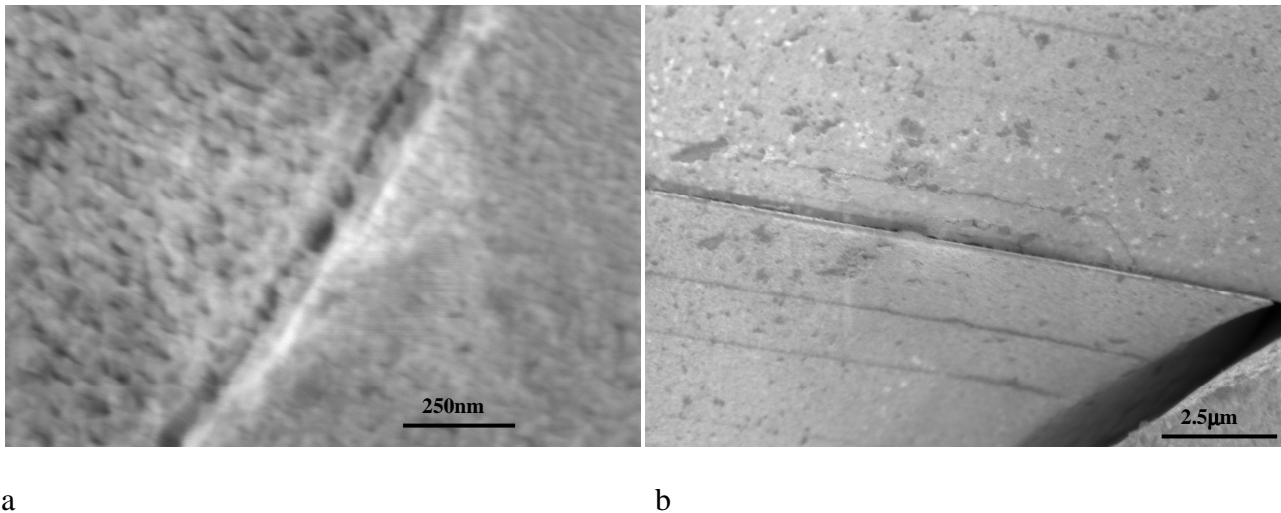
a b
Figure 8. SEM fractographs of grain facets in Allvac718plus (700°C dwell) a) oxidized surface with voids b) surface at lower magnification with one open and one closed secondary crack with voids.

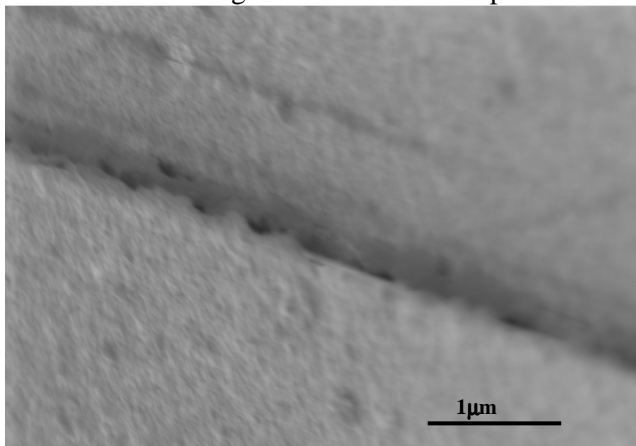
Figure 9. SEM fractograph showing the voids in the grain boundary shown in fig. 8b at higher magnification.
