# Fatigue Damaging Mechanisms in a Hot-Dip Zinc Coated Steel

**ABSTRACT.** *Hot-dip galvanizing is one of the most used methods to apply zinc-based coatings on steels, in order to provide sacrificial protection against corrosion over all the steel surface. The efficiency of the protection is affected by the coating mechanical response to loading: cracking and coatings delamination during forming and/or during service could decrease the corrosion resistance and could allow the contact between the environment and the substrate (the steel). In this work, fatigue damaging mechanisms of hot dip zinc coated steel plates were investigated by means of a non-standard fatigue-bending test performed considering high strain levels. Fatigue damaging micromechanisms were investigated by means of LOM (light optical microscope) analysis of metallurgically prepared longitudinal section of tested specimens, considering different applied cycle numbers (from 1 up to 1000).*

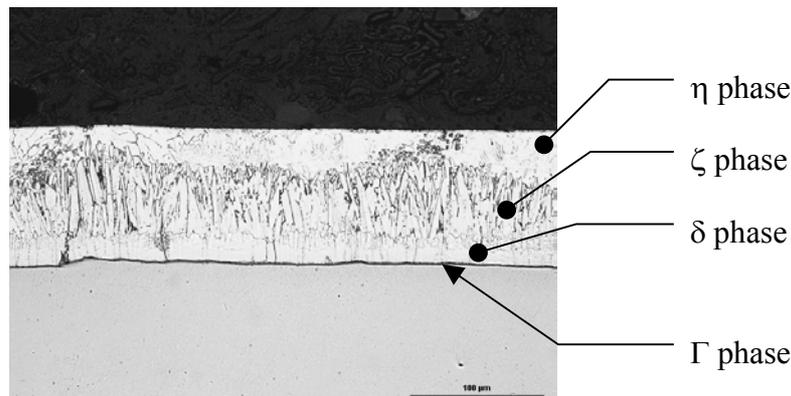
Figure 1: Zinc coating phases distribution

Zinc-based coating layer formation is obtained by diffusion of zinc atoms in iron and vice-versa. It is governed by physical parameters (bath temperature, immersion time, pre-galvanizing surface temperature, etc.) and chemical parameters (bath and steel chemical compositions, flux chemical composition, etc.) [2]. The result of the zinc coating is a multilayer system usually constituted by four phases (Fig. 1), characterized by different chemical compositions, thickness and mechanical properties. Outer layer is a ductile  $\eta$  phase with maximum Fe content up to 0.03%. The subsequent layer is named as  $\zeta$  phase, which is isomorphous with a monoclinic unit cell and an atomic structure that contains a Fe atom and a Zn atom surrounded by 12 Zn atoms at vertices of a slightly distorted icosahedron. The icosahedra link together to form chains and the linked chains pack together in a hexagonal array [3].  $\delta$  phase is a brittle one with a Fe content up to 11.5 wt%, with a hexagonal crystal structure. The last phase is a very thin layer named  $\Gamma$  phase and is characterized by a Fe content up to 29 wt% (fcc).

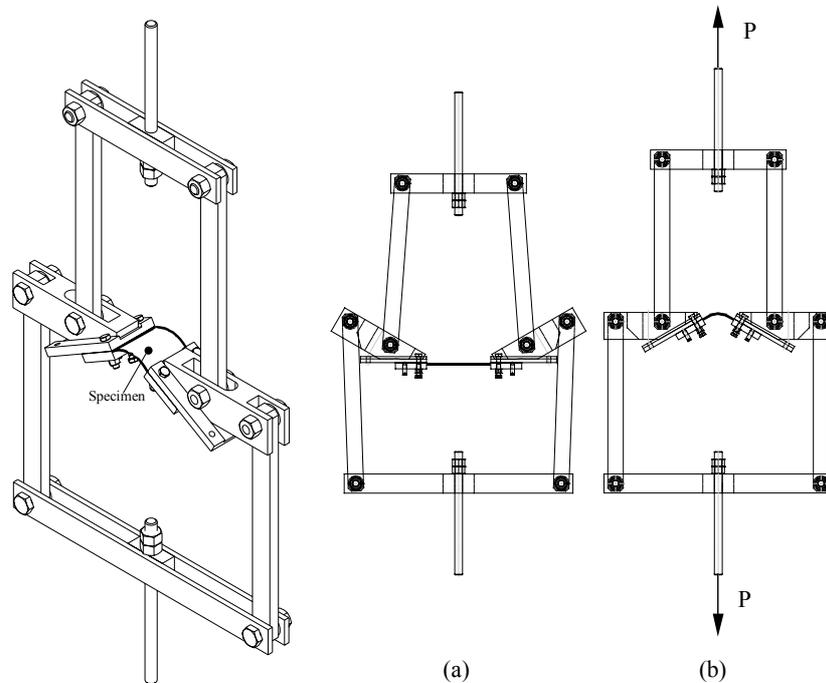
Figure 2: Clamping system for bending test (on the left). Different clamping configurations (on the right): a) starting position; b) generic position [10].

Both static (1 cycle) and cyclic bending tests were performed considering a non-standard device (Figure 2, on the left) and repeated four times for each investigated coating bath.

Tests were performed using an electromechanical 100kN testing machine, considering a crosshead displacement range between 9 and 11 mm, that corresponds to a bending angle range between  $9^\circ$  and  $11^\circ$  (figure 2b) [6 - 9]. Finally, in order to identify the damaging mechanisms for each investigated coating bath, longitudinal sections of the bended specimens were metallografically obtained and observed by means of an optical microscope (LOM). Damage level was evaluated in terms of “radial cracks density” (cracks number/length) considering 6 images for each specimen (damage level is obtained as the mean value of 24 measurements, with a very high repeability). Crack paths were also evaluated analysing their interactions with Zn-based intermetallic phases. As a consequence, damage evaluation was considered as strongly connected with cracks nucleation: authors are conscious of the limit of this definition that do not take into account the crack growth in the different phases.

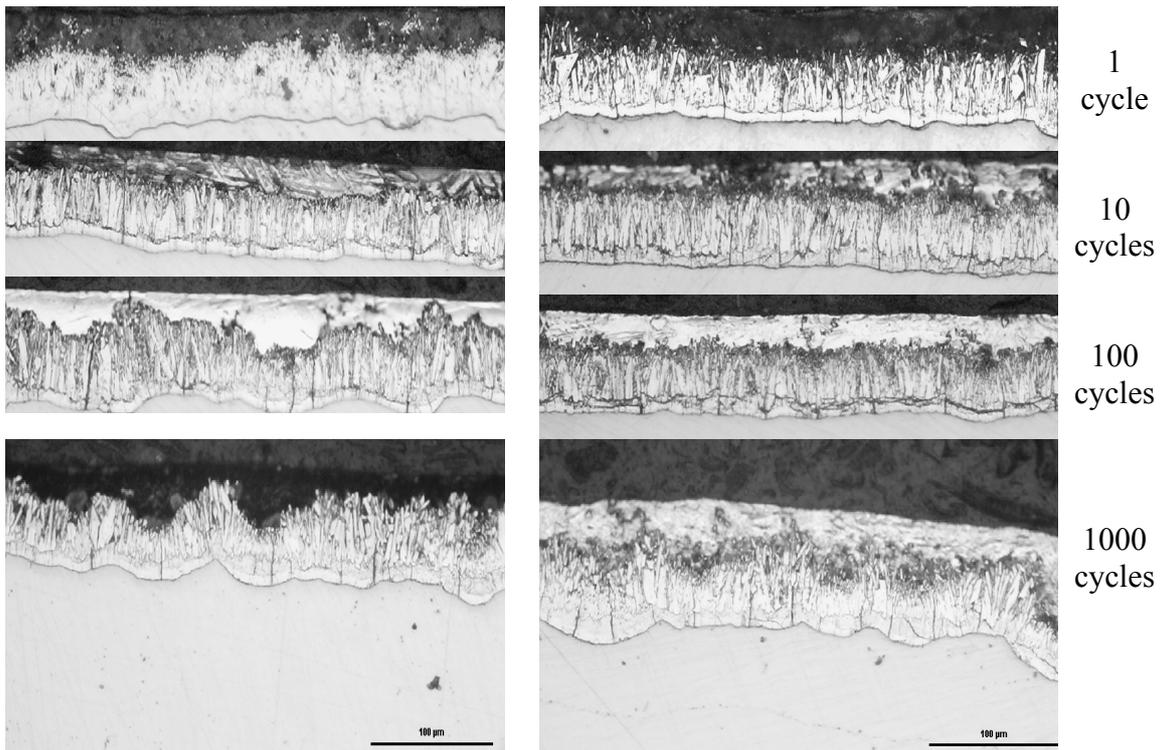
Figure 3. Crack path analysis. 0% Pb

Crack path analysis is shown in Figs. 3-6. Zn based intermetallic phases are characterized by different growing kinetics, implying an increase of their thickness as a function of the increase of the Pb content. Furthermore, morphological differences are

evident between microstructures obtained with a Pb content equal to 1% and the other values. In fact, for Pb wt% up to 0.5,  $\zeta$  phase is characterized by a columnar structure and corresponding to Pb wt% equal to 1.0,  $\zeta$  phase loses its columnar character. Microstructure analysis performed on the tested specimens does not allow to observe an evident  $\Gamma$  phase and does not show either radial or longitudinal cracks in  $\eta$  phase (the external one, almost pure Zn).

Longitudinal and radial cracks are observed as a function both of the bath chemical composition and of the loading conditions. Longitudinal cracks are not observed for Pb wt% equal to 0, for all the investigated cycles number. The increase of the Pb content implies the presence of longitudinal crack after 100 cycles, preferentially at  $\delta - \zeta$  interfaces. For Pb wt% equal to 1, longitudinal cracks are also observed inside  $\delta$  phase.

All radial cracks nucleate at  $\Gamma - \delta$  interface and propagate in  $\delta$  phase. A number of them could also propagate in  $\zeta$  phase, up to the  $\eta - \delta$  interface, where they definitely stop. Radial cracks are considered to evaluate the damage level (Fig.7 and 8, mean values). Both  $\delta$  and  $\zeta$  phases are characterized by an increase of the damage level with the increase of the cycles number, with an evident influence of the Pb content up to a Pb wt% equal to 0.5, with the lowest rate obtained with Pb wt% equal to 0.

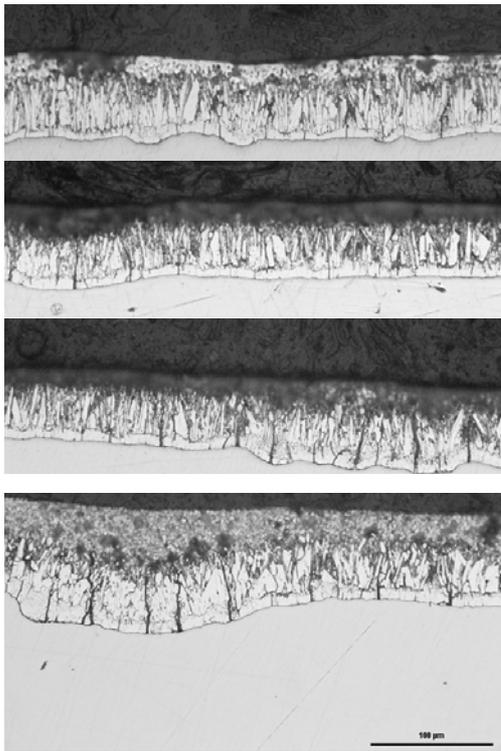
Figure 5. Crack path analysis. 0.5% Pb

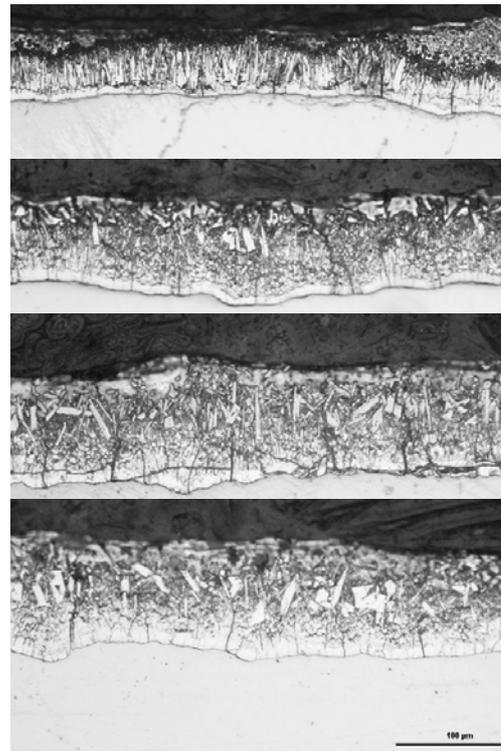
Figure 6. Crack path analysis. 1% Pb

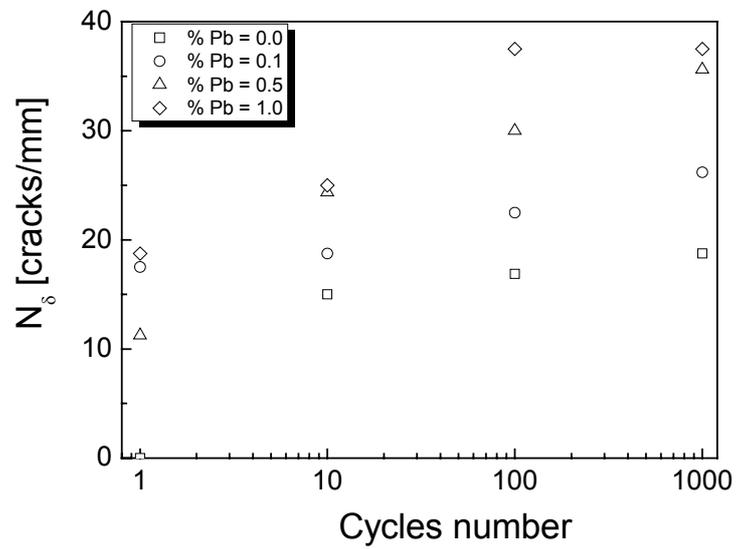
Figure 7. Damage level ( $\delta$  phase).

For Pb wt% equal to 1, damage values are comparable or also lower than the values obtained for Pb% = 0.5. Damage evolution in the two considered phases is similar. This peculiar behaviour is probably due to different mechanisms:  $\delta$  phase is characterized by an evident presence of longitudinal cracks, with a consequent decrease of the importance of the radial cracks nucleation;  $\zeta$  phase loses its columnar character, and, consequently, radial cracks are not still the preferential path. This mechanism is confirmed by the analysis of the evolution of the difference  $N_\delta - N_\zeta$ , that corresponds to

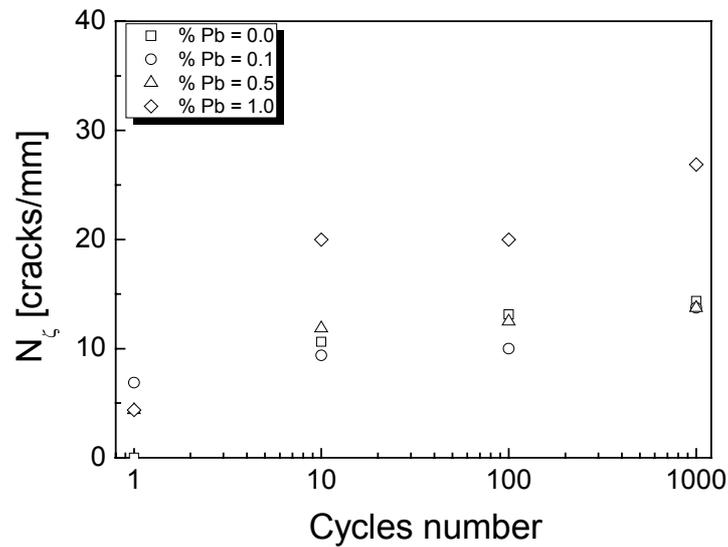
Figure 8. Damage level ( $\zeta$  phase).

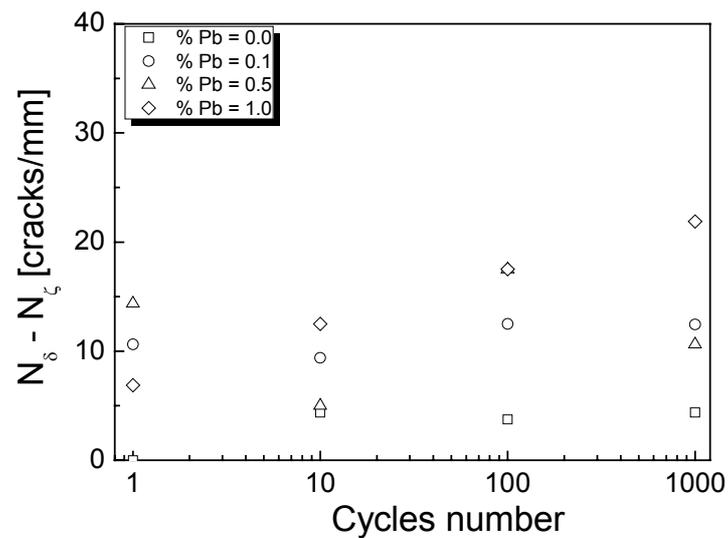
Figure 9. Cracks that do not propagate from  $\delta$  phase into  $\zeta$  phase.

the cracks number that do not propagate from  $\delta$  phase into  $\zeta$  phase (Fig. 9). For Pb% = 1, experimental values are linearly correlated with a very high correlation coefficient. This implies that crack propagation from  $\delta$  to  $\zeta$  phase is inhibited by the  $\zeta$  phase morphology that does not presents preferential paths, and consequently damage is concentrated as radial and longitudinal cracks in  $\delta$  phase. For Pb% = 0 and 0.1, differences " $N_{\delta} - N_{\zeta}$ " are practically constant: cracks propagate from  $\delta$  to  $\zeta$  phase and find preferential path up to  $\eta$  phase.
