Influence of Microstructure on Crack Paths in a Ferritic-Martensitic Steel

A. Brückner-Foit¹ Y. Motoyashiki and A. Sugeta²

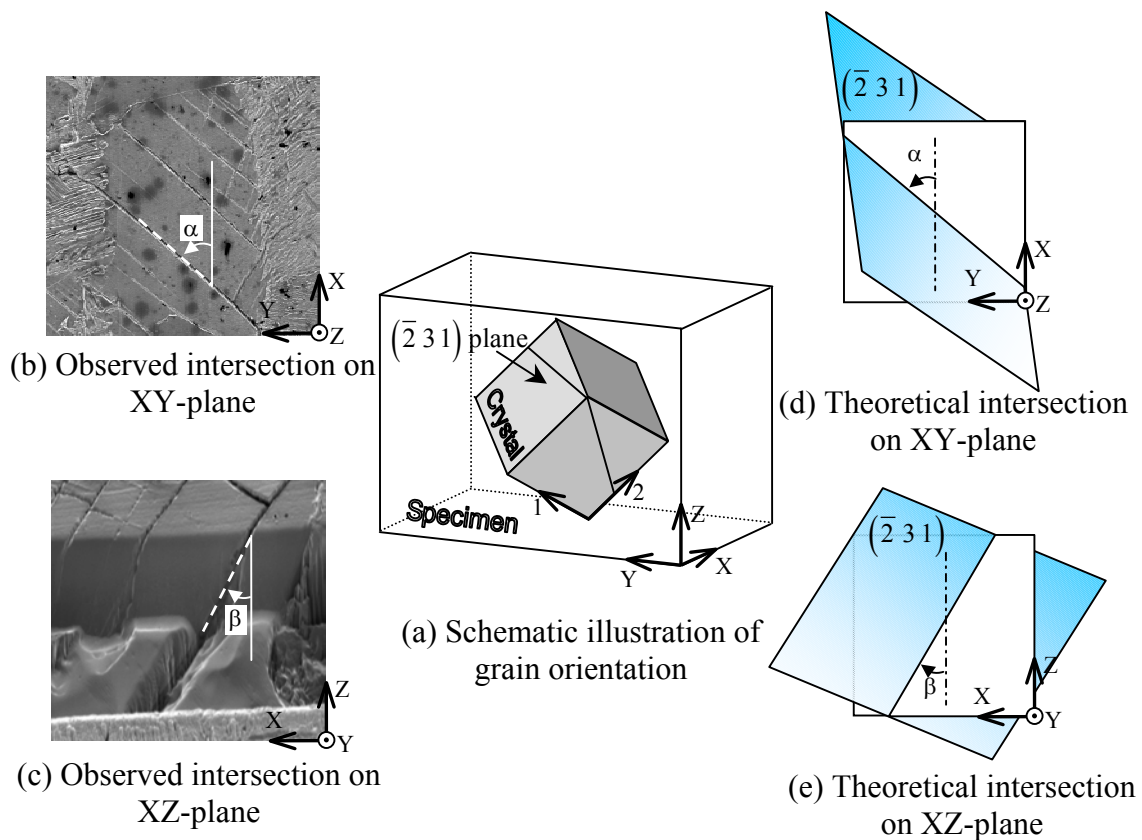
Figure 4. Schematic illustration of grain orientation, and theoretical and observed slip plane appearance on section area.

The crystallographic orientation was measured with the EBSD technique and the activated slip system among all 48 possible slip systems of a BCC crystal was examined. The grain was oriented as illustrated in Fig. 4 (a). The specimen surface and the plane created by FIB are the XY- and XZ-planes according to this coordinate system, respectively. Intersection lines of the crack plane were observed both on the XY- and XZ-planes, and on the XY-plane an angle of the intersection line with the respect to the loading axis and on XZ-plane an angle to the normal direction (Z-axis) were measured, which were denoted α and β respectively as presented in Figs 4 (b) and

(c). Note that Fig. 4 (c) was originally taken at the tilt angle of 45° and is here expanded in Z direction to measure the angle β . When the angles of α and β of all possible slip planes were calculated, one slip system of $(\bar{2}31)[11\bar{1}]$ showed very good coincidence with the observed slip bands, as schematically illustrated in Figs 4 (d) and (e). Schmid Factors of all the slip systems in this grain were also calculated and this slip system had the highest value of 0.499. The Schmid Factor indicates the activity of slips in a ductile material. Thus it can be said that this slip system was activated in this grain and the crack initiated as a result of the slip activation. This result shows that the subsurface observation with the help of crystallographic measurement provides a means to identify the active slip system in a grain.
