Fatigue Damage Evolution in Graded Materials

ABSTRACT. *The fatigue damage evolution of a thermo-mechanically graded material is investigated within the framework of an ongoing collaborative research center (SFB/TR TRR 30). The first results are presented which deal with the fatigue behavior of a flange shaft. The base material is a CrV-alloyed heat treatable steel in an engineering condition. The steel has a nearly fully pearlitic microstructure in the initial state, i.e. in an annealed condition. A martensite phase is formed in parts of the flange rod in the course of the thermo-mechanical treatment. The fatigue behavior of the different regions and their damage mechanisms leading to failure are identified. A procedure of determining the lifetime of the flange shaft is presented.*

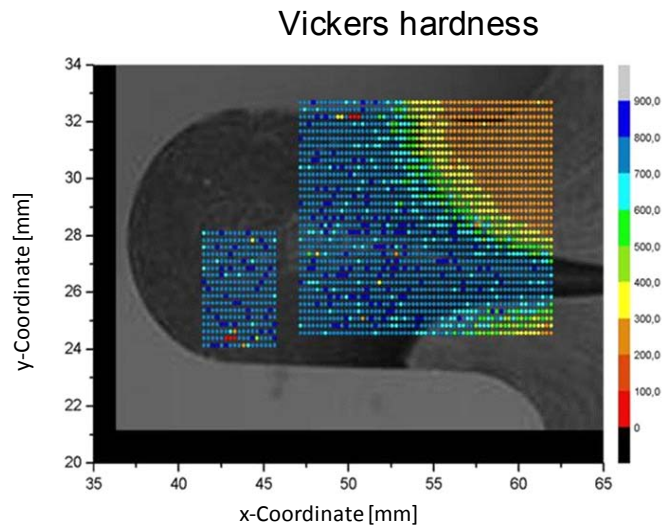
More information on the local microstructure can be obtained by measuring the local hardness. Fig. 2 shows the results where the lighter colors are related to the softer phases.

Figure 2. Estimated values of the Vickers hardness in the transformed area

Comparison of Fig.1-2 and Fig.3 shows that the specimens with the last digit 1-4 (E2- E4 in Fig.5) were taken from the martensite area whereas specimens number "... - 4" and "...-5" contained a mixture of microstructures ranging from base material to martensite. Hence it was possible to investigate both the tensile properties and the fatigue properties of the flange. In addition specimens were cut from the base material to study the mechanical behavior of the undeformed material. In this case round bars with flat notches were manufactured in addition to the small hourglass specimens described above.

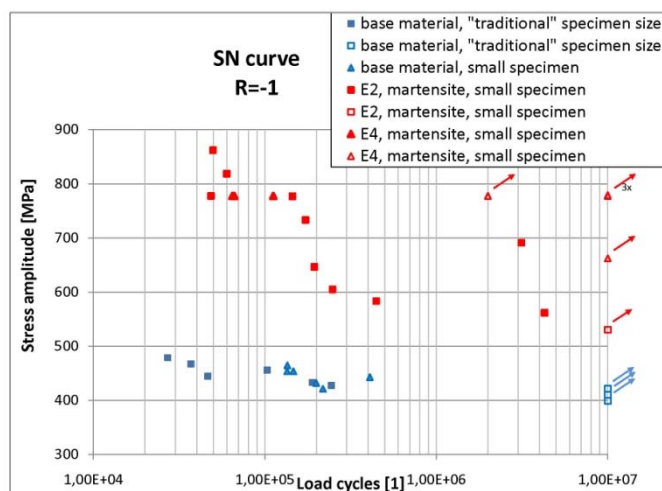
Fig. 5 summarizes the result of load-controlled fatigue tests with $R=-1$. It can be seen that the life times of specimens taken from the transformed regions are much higher, and that there is not much difference between three outer locations in the flange. Moreover, the lifetimes in the transformed regions show a considerable amount of scatter.

Figure 5. Fatigue life times of specimens cut from the flange

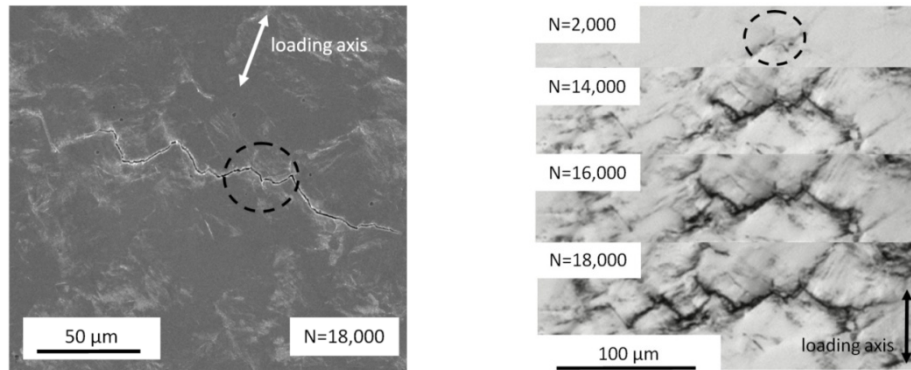
The orientation of most sections of the crack is either 45° or perpendicular to the loading axis. The two dashed circles mark the same section of the zig-zag crack. After 2,000 load cycles a few former pale shades (appeared after 1,000 cycles) became dark lines. These lines propagated during the next 1,000 load cycles, and therefore either they were already real microcracks after 2,000 cycles, or they became real microcracks within the following load cycles. However, in this paper such lines are treated as microcracks, and with this practical simplification the crack propagation curve of the zig-zag crack is given in Figure 9. Figure 9 shows the accumulated crack propagation rate, i.e. the lengths, and the resulting propagation rates, respectively, of all existing sections of the final crack during one scan are summed up. Therefore this diagram of accumulated values represents a kind of averaged crack propagation rate. The typical stop-and-go behaviour of small cracks is observed. The cracks were initiated at grain/phase boundaries (2). Crack stop was caused by pearlite with a comparably high density of cementite lamellae; after changing the direction the cracks continued with intercrystalline propagation. All microcracks (in this case three) coalesced after 7,000 load cycles. The low propagation rate (8) is caused by a pearlitic area with lamellae perpendicular to the crack propagation direction on one side of the crack, i.e. this side is

arrested, and the crack propagates only towards the other side. A similar reason is found for the reduced propagation rate at (10); here one side of the crack has to pass through a field of plastic deformed pearlite whose cementite lamellae lay again nearly perpendicular to the crack path. Finally the crack propagation rate increases steadily after the crack has reached a length of about 75 μm .

Figure 8. SEM picture (before etching) and optical microscope pictures showing the same zig-zag crack

Figure 7 illustrates the observation that most of the comparably large areas showing hardly any or no plastic deformation (Fig.6) correspond to fully pearlitic zones with comparably small spacing between the cementite lamellae (see Fig.7). The effect of the microstructure on the crack propagation is studied by comparison of the SEM pictures (all taken after 18,000 load cycles) with the pictures taken periodically with the long distance microscope. Figure 8 illustrates the procedure.

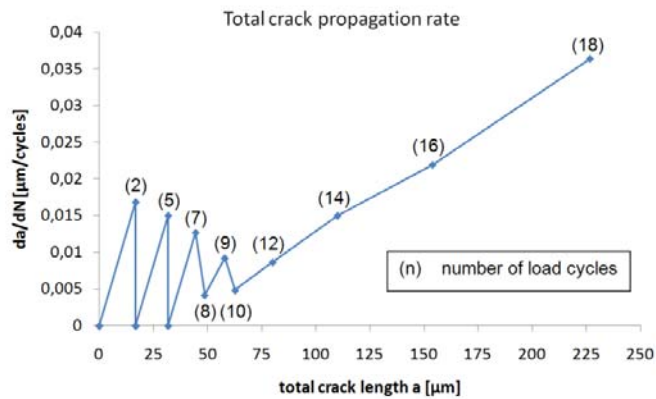
Figure 9. Total crack propagation rate of zig-zag crack

Similar results were found for the other investigated cracks; the propagation rates of all of them increased steadily after they reached a length of about 75 to 100 μm . It was also found that coalescence of microcracks plays an important role. This is a result of the high crack/line-like damage density (see Fig. 6).
