Evaluation of rolling contact fatigue crack path of high strength steel with artificial defects

T. Makino¹, Y. Neishi¹, D. Shiozawa², Y. Fukuda² and Y. Nakai²

¹ Corporate Research & Development Department, Sumitomo Metal Industries, Ltd., JAPAN, makino-tiz@sumitmometals.co.jp

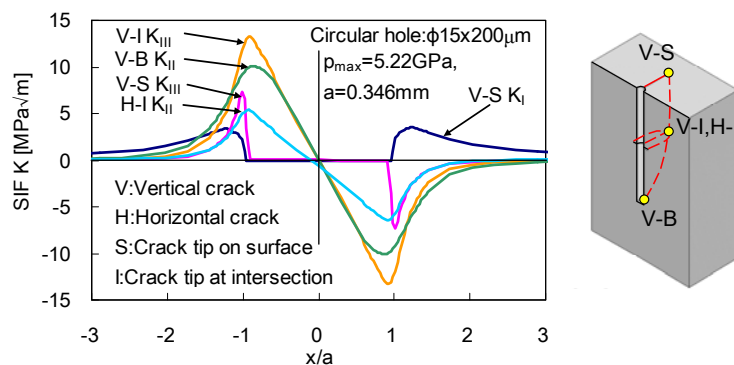
Fig. 7 shows the change in the SIFs of vertical and horizontal cracks with a circular hole during rolling contact. Some peaks and valleys of SIF appear at various points. The largest peak and valley of SIF is that at mode II SIF K_{II} which occurs at the tip of an intersection of a vertical crack with a horizontal crack (V-I). Two peaks of mode I SIF K_I at the tip on the surface (V-S) occur before and after rolling contact.

Figure 7. Change in the SIFs of cracks with a circular hole during rolling contact.

Fig. 8 shows the comparison between the ranges of SIF ΔK obtained from Fig. 7 and the fatigue crack threshold SIFs ΔK_{th} . The mode II and III threshold SIFs ΔK_{IIth} and ΔK_{IIIth} of the tested material have not been investigated yet. However, those using a material of similar hardness (bearing steel) were investigated by some researchers [7]. Assuming that the threshold of SIFs are the same for both tested material and bearing steel, those by Matsunaga et al. [7] are indicated in Fig. 8.

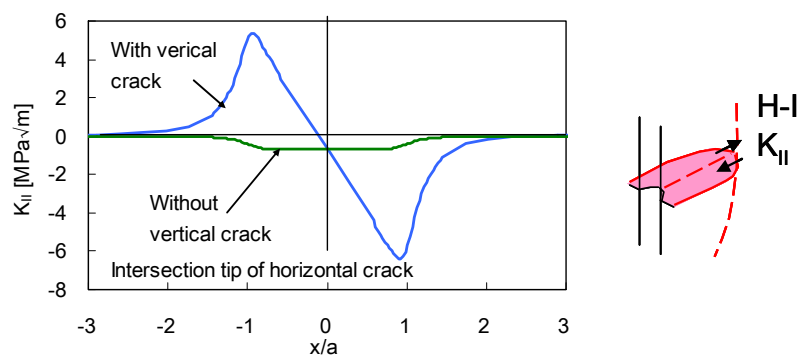
In order to clarify the interaction of vertical and horizontal cracks, two FE models as shown in Fig.5(d) and (e) were calculated. Note that (d) is a model with only a vertical crack, while (e) is a model with only a horizontal crack. The SIFs of vertical cracks were the same in both models with and without horizontal crack. Fig.9 shows the comparison of SIF of horizontal cracks between two models with and without vertical cracks. The mode II SIF of horizontal cracks at an intersection with vertical cracks is larger than that at the same point in the model without vertical cracks. It suggests that a vertical crack accelerates the propagation of a horizontal crack. This would mean that the restraint against shearing deformation of horizontal crack reduces due to vertical cracks. The interaction of both cracks would appear to dominate RCF crack propagation originated from artificial defects.

Figure 9. Comparison of SIF of horizontal crack between two models with and without vertical cracks.

- (5) In comparison of SIF of horizontal cracks between two models with and without vertical cracks, the mode II SIF of a horizontal crack at an intersection with a vertical crack is larger than that at same point in the model without a vertical crack. It suggests that the vertical crack accelerates the propagation of horizontal cracks.
