# Crack Formation and Crack Path in CFRP Machining

**ABSTRACT.** *During milling of carbon fiber reinforced plastics (CFRP) material a very distinct material removal process has been identified. Instead of forming continuous chips of a certain size, the material is removed in a powder-like fashion shooting out of the tool / workpiece contact area. The brittle, powder-like chip formation in cutting CFRP suggests crack formation as main material removal process. Analyzing the material removal for different fiber orientations characteristic matrix (epoxy) and fiber failure behavior can be identified. Some orientations show a frequent crack formation reaching deeper into the structure, while for others the matrix and fiber removal takes place only at the very surface. The crack path in the epoxy matrix and in the fibers depends on the fiber orientation relative to the trajectory of the cutting edge, respectively tool. Matrix removal and fiber fracture is minimum and limited to the surface itself when the cutting takes place parallel to the fiber orientation or the tool is running on fibers which gradually ascending to the surface. The most complex crack formation is observed when the

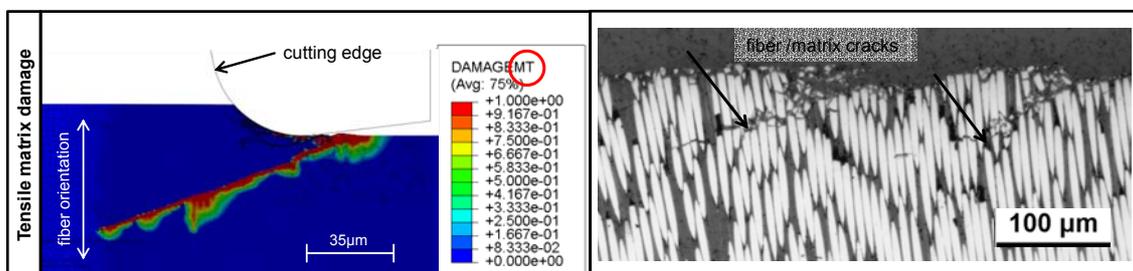
In case of the crack formation in CFRP with a  $90^\circ$  fiber orientation, the macroscopic model with the implicit fiber property representation revealed an excessive matrix tension as significant failure loading mode (cf. Fig. 6). Also the angle of the failure path in the FEM model agrees very well with the crack path observed in experiment. The shows that the crack is initiated behind tool / workpiece contact.

Figure 6. Main CFRP damage for  $90^\circ$  fiber orientation by matrix tensile failure (left, macroscopic model) and its respective experimental observation (right)

Because of material compression in front of the cutting edge (in Fig. 6 cutting from right to left), tensile stresses are generated relative to the non-compressed regions (in CFRP mainly in fiber direction). The matrix tensile damage mode (cf. DAMAGEMT in scale of Fig.6) reveals the transition region between these two differently loaded areas. The frequently occurring cracks hint at a cyclic occurring effect during cutting possibly due to friction related slip-stick in the tool / workpiece contact.
