**Fatigue Fracture Behavior of Single-Edge-Notched
Specimens Prepared From Polyethylene Pipes**

H. JAAFAR and G. FERNANDO*

This paper presents a comparative analysis of crack propagation behavior of single-edge-notched (SEN) specimens prepared from high density polyethylene (HDPE) and medium density polyethylene (MDPE) gas grade pipes tested under fatigue loading conditions. The rate of crack growth was found to be influenced by the morphology in the pipe. The crack propagation behavior was governed by the plasticity at the crack tip which in turn was linked to the sample crystallinity. The effect of oven aging on fatigue life was also addressed. Oven aging was found to increase the crystallinity which resulted in lowering the fatigue life.

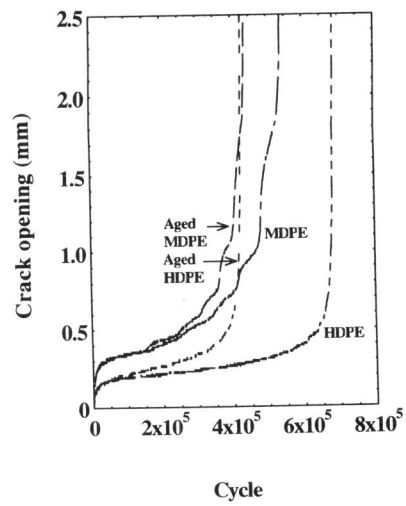
Figure 5. Crack opening as a function of fatigue cycles for aged and unaged pipes.

The relative fatigue performance of the MDPE and HDPE pipe samples are shown in Figure 5. With reference to Figure 5, the crack opening displacement measurement was plotted as a function of cycle for both the pipe resins. The initial stage of the curves was identified as that due to nonrecoverable creep at the notch tip, promoting a ductile crack arrest. The fatigue life was found to be longer for the HDPE samples. However, when the two pipes were aged in an air-circulating oven for one year at 80°C, the fatigue life for HDPE drooped significantly to a level lower than that observed for the aged MDPE pipe, see Figure 5. The crystallinity content in both pipes were measured and was found to increase considerably throughout the pipe wall after aging. This was attributed to thermal annealing of the polymer at 80°C. This phenomenon was studied extensively by Rueda et al. (7). They suggested a lamellar diffusion mechanism to occur at elevated temperatures which in turn was said to lead to the increase in the crystallinity. The increase in crystallinity is proposed as a possible reason to account for the observed fatigue results for the aged pipes. The rate of crystallinity increase was found to be higher in the case of HDPE resin.

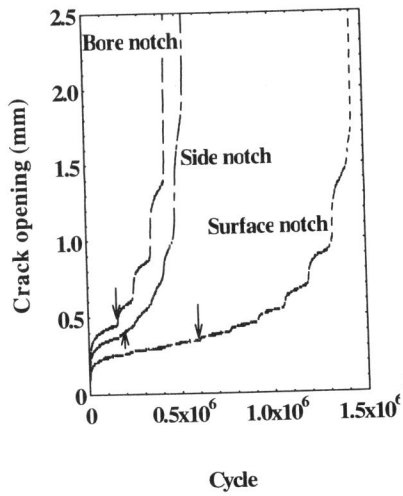
Figure 7. Crack opening as a function of fatigue cycle for different notch location.

As mentioned previously, the PE pipes have a morphology-gradients throughout the wall thickness. The effect of this was studied by plotting the crack opening displacement as a function of cycle using three different notch locations: (a) outer surface notch; (b) inner surface notch; and (c) side notch. It is clear from Figure 7 that the rate of crack growth is influenced by the level of crystallinity ahead of the notch tip.
