**HIGH TEMPERATURE CORROSION FATIGUE OF PLATINUM COATED
MAR-M002 NICKEL-BASE SUPERALLOY**

The corrosion fatigue behaviour of platinum coated unidirectionally solidified MAR-M002 was investigated in air, argon and Ar + 5%SO₂ atmospheres at 870°C. The neck of the fatigue samples were coated with 4-6µm of platinum by an electroplating process. The coated fatigue samples were exposed to a constant creep-fatigue loading with creep in tension and plastic compression. Due to the interdiffusion between platinum and the alloying elements, the corrosion resistance of the alloy was not influenced significantly when compared to uncoated MAR-M002. Although the coating provided adequate protection in oxidation environment, it was susceptible to sulphidation attack. The combined effect of creep-fatigue loading and sulphidation attack resulted in an accelerated failure.

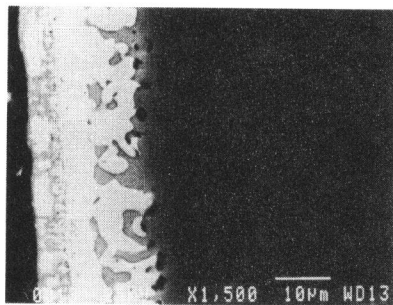
Figure 1: Characterization of platinum coated MAR-M002.

Characterization of the coating revealed a platinum rich outer layer and a γ' denuded region adjacent to this layer (figure 1). The coating thickness including the γ' depleted zone was measured to be approximately 15 μ m. Aluminium content in the γ' denuded zone was significantly lower than the substrate as a result of the formation of platinum aluminide phases and the effect of platinum enhancing the diffusion of aluminium to the outer surface (Fountain *et. al.* (5)). The platinum rich layer was made up of two distinct regions identified by their shading: the grey region and the white region. These regions showed distinct difference in their elemental composition. The both regions were made up essentially of Ni and Pt with some smaller amounts of other alloying elements being present. The grey region showed a lower aluminium content and higher Ni, Cr, Co and W content than the white region with Ni being the major constituent. In the white region the Al content was higher and the Pt was the major constituent. This indicated that the grey region was made up of Pt dissolved in nickel and intermetallic phases of Pt containing Cr, Co, and W while the white region can be regarded as essentially a Pt-Ni alloy with the presence of the substrate alloying elements in it. X-ray diffraction analysis produced a spectrum with a number of broad peaks. This indicated that there was incomplete transition of phases and

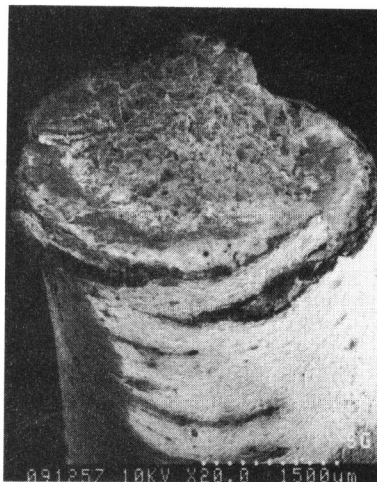
Figure 2: Fractography of platinum coated MAR-M002 after HTLCF in Ar + 5%SO₂.

Fractography analysis of a platinum coated sample after HTLCF in SO₂ bearing atmosphere revealed the presence of dark corrosion product on the fracture surface (figure 2). It was evident that two cracks propagated simultaneously to failure. Crack propagation occurred in the "smooth" region and final failure occurred in the coarse region. Peeling of the coating and severe localized sulphidation attack, resulting in swelling of coating was observed (figure 3). Cross-sectional examination showing the fracture surface/coating intersection showed the peeling away of the coating (figure 4) from the substrate. The γ' denuded zone was susceptible to sulphidation attack due to the depletion of aluminium from this region. As a result the corrosion process proceeded most rapidly in this region resulting in delamination of the coating from the substrate. The grey region in the coating was sensitive to sulphidation, with internal sulphidation in these regions being very evident resulting in "porous" regions filled with the sulphides of Ni and Cr. The sulphidation attack

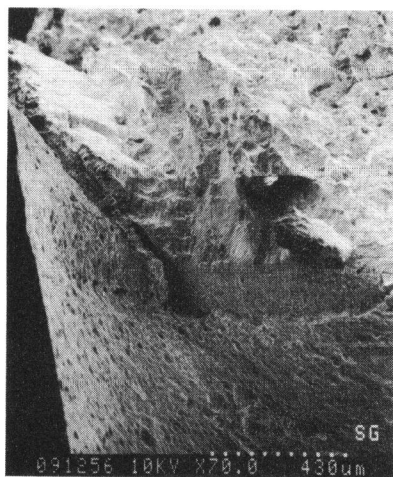
Figure 3: Fractography after HTLCF in Ar + 5%SO₂ showing peeling of coating

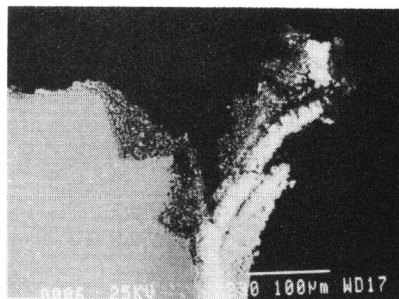
Figure 4: Cross-section of platinum coated MAR-M002 after HTLCF in AR + 5%SO₂

of the of the γ' depleted zone resulted in a "porous" region with the "pores" being filled with sulphides of Ni and Cr. There was no evidence of oxygen present in the corrosion product in these "pores", hence, indicating that sulphur was transported more readily through the coating than oxygen. Exposure of a platinum coated sample to Ar + 5%SO₂ at 870°C revealed the formation of the following oxides and sulphides: Cr₂O₃, Al₂O₃, Cr₅S₈, Cr₂S₃, CrS₄, CrS, NiS, Cr₇S₈ and Ni₃S₂. There was no evidence of Pt participating in the corrosion reactions.
