Surface Damage Evolution of Graded Materials

Abstract. The surface damage evolution of graded materials is investigated within the framework of an ongoing collaborative research center. The first results are presented which deal with the fatigue behavior of engineering steel with an inhomogeneous microstructure. Standard fatigue tests were performed, and the surface damage evolution was observed using an optical long distance microscope. The fatigue test was stopped before failure of the specimen, and SEM pictures of the etched specimen were taken in order to investigate the effect of microstructure on the fatigue behavior. Finally a simple damage parameter is used in order to quantitatively describe the surface damage state.

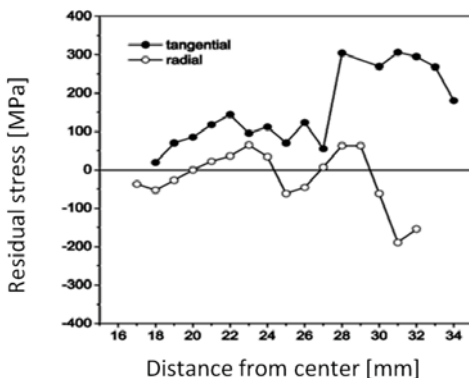
Fig. 4: Residual stresses measured on the top of the flange shaft (see Fig. 3, surface A: striped area)

The raw material in the unaffected zone shows comparably low residual stresses around 0 MPa (tangential and radial; error about ± 15 MPa). The tangential residual stresses rise up to about

300 MPa in the flange, whereas the radial residual stresses oscillate around 0 MPa. This behavior is related to the thermo-mechanical forming process [12]. The thermal influence basically results in a martensitic transformation, and the martensite is subjected to tension residual stresses. The mechanical forming of the flange causes compressive strain and compressive stress, respectively in radial direction, and tension strain in tangential direction. The superposition of the mechanically induced residual stresses with the transformation induced residual stresses results in the residual stress distribution shown in Figure 4.

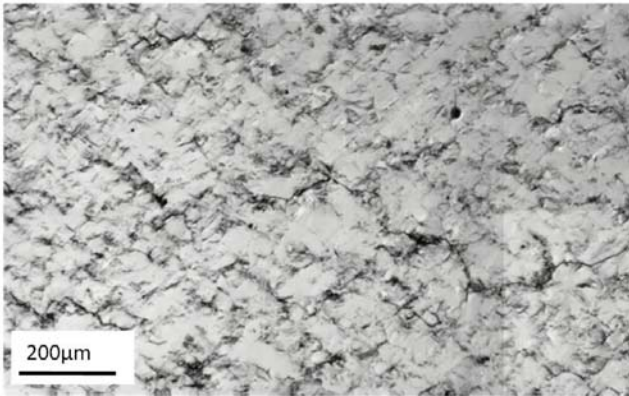
Fig. 5: Extract of the surface scan taken after 18,000 load cycles

The whole surface of the notch (area of stress concentration) is covered with small microcracks and localized plastic deformation, respectively. On the basis of the pictures taken with the optical long distance microscope (Fig. 5) it is difficult to distinguish between microcracks and strong line-like plastic deformation due to the fact that both appear as black lines. But both of them represent an area of locally reduced material strength and therefore contribute to the damage state. As a result in this research work it is not necessary to distinguish clearly between localized line-like plastic deformations (which are becoming cracks) and well defined cracks. This statement can be justified based on Figure 6. Although the etching took only 6 s, and afterwards the specimen was cleaned carefully, new small microcracks appeared immediately after etching in the areas of high plastic activity (see right picture of Fig. 6).

Three different sites of crack initiation were identified for the raw material. Crack initiation was found at sulphide inclusions, pits, in the ferrite phase, and at its phase boundaries (ferrite/pearlite), respectively. Figure 5 shows an area of about $0.8 \times 1.3 \text{ mm}^2$ of the damaged surface after 18,000 load cycles. The polished surface became rough due to local plastic deformation caused by the cyclic loading.

Figure 6 is representative for the observation, that most of the comparably large areas showing hardly any or no plastic deformation (Fig. 5) correspond to fully pearlitic zones with comparably small spacing between the cementite lamellae (see Fig. 6).

As mentioned above the experiment was stopped because three cracks were found which were about to coalesce, which would result in one crack with a length of more than 500 μm (see Fig. 5, lower right side). At that moment a total of 15 cracks with a length of about 200 μm (or longer) existed on the observed surface. The crack paths of one third (i.e. five) of them were examined in more detail by SEM observations. The effect of the microstructure on the crack propagation is studied by comparison of the SEM pictures (all taken after 18,000 load cycles) with the pictures taken periodically with the long distance microscope. Figure 7 illustrates the procedure.

for the other investigated cracks; the propagation rates of all of them increased steadily after they reached a length of about 75 to 100 μm . It was also found that coalescence of microcracks plays an important role. This is a result of the high crack/line-like damage density (see Fig. 5).
