DUCTILE FRACTURE IN A V/Nb DUAL PHASE STEEL

V. Radmilović, Dj. Drobnjak and M. Rogulić \*

The role of martensite in ductile fracture of a V/Nb dual phase steel is studied by means of tensile testing and scanning electron microscopy. The results show that the properties of martensite play an important role in the initiation and propagation of the cracks in a dual phase structure. In addition to the ferrite/inclusions decohesion the crack initiation and propagation by the ferrite/martensite decohesion and martensite cracking controle the fracturing process in the presence of a soft low-carbon and a hard high-carbon martensite respectively.

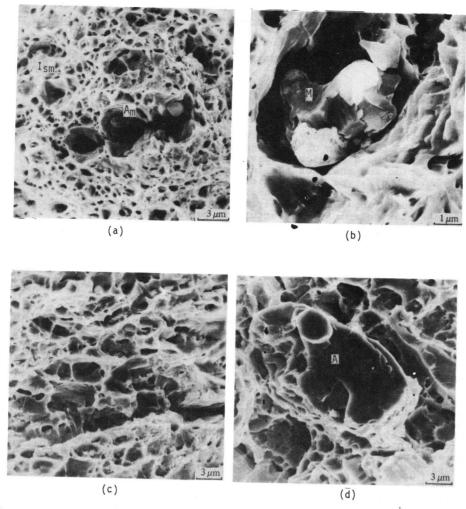
Fig. 4 - Scanning electron fractographs of step quenched (Fig. 1a, b) and directly quenched samples (Fig. 1c, d) showing facets (A) and dimples associated with: residual microscopic inclusions (denoted by  ${\rm A_m}$ ); residual martensite (M) and submicroscopic inclusions (I $_{\rm Sm}$ ).

Observation of the fractured surface revealed two types of dimples in the step quenched structure. The first type in the form of deep cavities is associated with residual microscopic inclusions (Fig. 4a) and/or residual martensite islands (Fig. 4b). The second type of dimples, less than 0.5  $\mu m$  in diameter, are associated with the submicroscopic inclusions (Fig. 4a). In the directly quenched specimens, in addition to dimples (Fig. 4c), a well defined facets are observed (Fig. 4d).

In the presence of the hard high-carbon martensite, the martensite cracking, in addition to the ferrite/inclusion decohesion, plays a major role in the initiation and propagation of the cracks. A number of cleavage cracks in martensite give rise to the formation of facets at the fractured surface. However, cracks initiated by fracturing thin martensite plates (denoted by arrow in Fig. 3b) develope into voids by ferrite/martensite decohesion (denoted by arrow in Fig. 3d). These voids coalesce with the voids originating from the inclusions, giving rise to the formation of the dimples, which coexist with the facets at the fractured surface.

In the presence of a high-carbon martensite (obtained by quenching from a temperature low in the alpha + gama range), a well defined facets on the fracture surface, and a number of crack perpandicular to the tensile axis which extends across the martensite, are also observed. This is taken to indicate that cleavage may play an important role in the fracture process, depending upon the properties of martensite.
