Initial Stages of Hydrogen Induced Short Fatigue Crack Propagation

REFERENCE de Miranda, P. E. V. and Pascual, R., **Initial Stages of Hydrogen Induced Short Fatigue Crack Propagation**, *The Behaviour of Short Fatigue Cracks*, EGF Pub. 1 (Edited by K. J. Miller and E. R. de los Rios) 1986, Mechanical Engineering Publications, London, pp. 179–190.

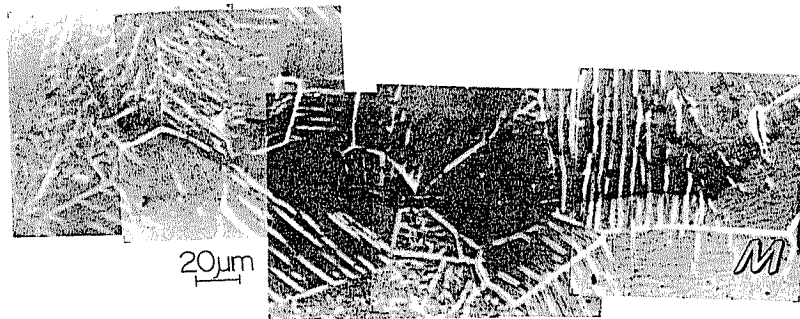
Fig 4 Early indication of the fatigue sub-surface crack appearing on the surface of the hydrogenated and outgassed sample at 49 per cent of its fatigue life. Unetched

In all the specimens observed, the main fatigue crack developed in the way represented in Figs 4, 5, and 6, which correspond to the same region of the surface of a particular specimen. Some dark markings, such as the one shown in Fig. 4, were found to appear on the gauge surface of the specimens and grow in length with increasing number of fatigue cycles. One of the marks was always found to be associated with the main fatigue crack responsible for fracture (Fig. 6). In brief, the main crack developed sub-surface and was visible at first as a dark marking on the surface. Only by the end of the fatigue life did the main fatigue crack open to show a crack on the surface. The sub-surface crack depicted in Fig. 4 was photographed after the sample was cycled 49 per cent of its fatigue life. It is interesting to note that it spread transgranularly, crossing without distinction grains with and without hydrogen-induced surface cracks, and did not follow the direction of these cracks, so that it cannot be thought to be formed mainly as a consequence of the in-depth growth of hydrogen-induced cracks. The same sub-surface crack of Fig. 4 has grown much longer after cycling the sample about 63 per cent of the fatigue life as shown in the micrograph of Fig. 5. In both Fig. 4 and Fig. 5 the white markings (white lines) represent the sites where there are intergranular and transgranular hydrogen-induced surface cracks. In a few regions of Fig. 4 (which was taken with greater magnification) the martensitic phase (marked M) can be noted. No relationship between this phase and the sub-surface cracks was found. Finally, Fig. 6 shows the crack at the end of the fatigue life in the same region circled in Fig. 5.
