# Hydrogen re-embrittlement of aerospace grade high strength steels

R. Valentini, C. Colombo, M. De Sanctis, G. Lovicu Department of Chemical Engineering, University of Pisa, Pisa (Italy) r.valentini@diccism.unipi.it

**ABSTRACT.** Hydrogen Re-Embrittlement on anodically coated high strength steels is a relevant risk for aerospace structures due to the possibility of hydrogen uptake during the operative life of the components. AISI 4340 and Maraging 250 unnotched tensile specimens were subjected to SSRT in order to evaluate the influence of test environment on time to failure. Fracture surfaces were examined by SEM analysis to evaluate the degree of embrittlement and to correlate it with hydrogen diffusivity of the tested steels.

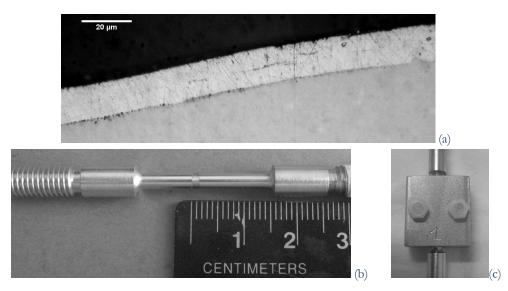
Figure 1: (a) Optical microscope picture of Zinc layer (500X), (b) Zinc coated round unnotched tensile specimen with the annular exposed steel area and (c) galvanic coupling made of AISI 316.

Cylindrical unnotched specimens (3 mm of diameter and 25 mm of gage) were used for HRE tests. Specimens were anodically coated with a layer of Zinc (15  $\mu$ m) as visible in Fig. 1 (a) to obtain a high current associated to hydrogen reduction. To expose the underlying steel, Zinc was removed from an annular area (1 mm wide) shown in Fig. 1 (b). Mechanical tests (SSRT at a strain rate of  $3.3 \cdot 10^{-5} \, \text{s}^{-1}$ ) were performed in the following conditions: air, 3.5% NaCl aqueous solution and paint-stripper. Further tests in salt solution were conducted with the addition of a galvanic coupling to recreate the enhancing effect of a nobler material on HRE. For this particular test, the coupling was made of AISI 316 (austenitic stainless steel), for its high galvanic activity and its good availability and workability. The coupling was made in two symmetrical halves and designed with a cylindrical cavity with the same nominal diameter of the specimen. Specimen and coupling were assembled like shown in Fig. 1 (c) to provide a suitable crevice for HRE.

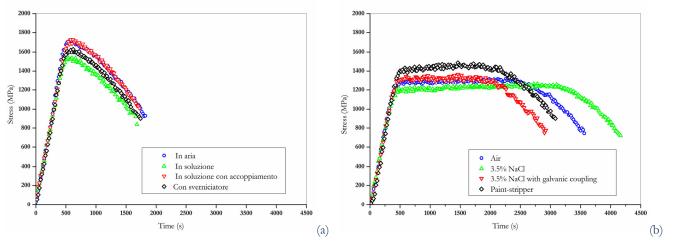
Figure 3: Stress-Time to Failure curves for Maraging peak-aged at 480°C (a) and at 535°C (b).

Results of SSRT campaign are presented, as a function of time to failure and environment, in Tab. 2. Figs. 2 to 3 show the measured stress as a function of time for the AISI 4340 and Maraging 250 respectively. From the curves of Fig. 3, it emerges as the shortest time to failure for AISI 4340 (551 s compared to 2490 s of the specimens loaded in air) was measured for the specimens subjected to painting and then stripped. Specimens, tested in salt solution,

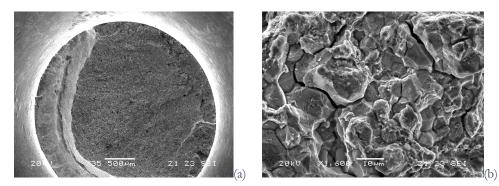
Figure 6: (a) Fracture surface for AISI 4340 specimen and (b) X1000 magnification for test with paint-stripper.

with and without galvanic coupling failed in comparable times. In particular, the specimens coupled to AISI 316 failed inside the galvanic coupling, even if externally to the exposed area. Fig. 4 (a) shows both the absence of necking and the ring of zinc corrosion products for one of the specimens involved in the latter test. Regarding Maraging 250, any of the curves related to the specimens loaded in corrosive environment differed significantly from the trend associated to the test performed in air. In detail, time to failure for Maraging peak-aged at 480°C were approximately equivalent in all the conditions, whereas the curves related to the Maraging peak-aged at 535°C differed slightly both for time to failure and sustained load. Furthermore, it was observed that all Maraging 250 specimens presented ductile necking like the one showed in Fig. 4 (b). Results from scanning electron in microscopy (SEM) analysis are shown in Figs. 5 to 10 for the most significant tests. According to fracture surfaces of Fig. 5, test in air for AISI 4340 resulted in a ductile rupture. Conversely, Fig. 6 displays a brittle fracture for AISI 4340 specimens loaded after paint-stripper application. SEM analysis on Maraging 250 surface fractures confirmed what was visible at naked eye in Fig. 4 (b), that is all the specimens failed with a cup-cone fracture as visible in Figs. from 7 to 9 independently of the test environment.

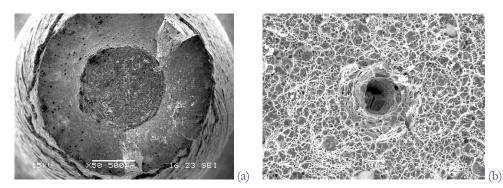
Figure 7: (a) Fracture surface for Maraging 250 specimen peak-aged at 480°C and (b) X1000 magnification for test in 3.5% NaCl aqueous solution with galvanic coupling.

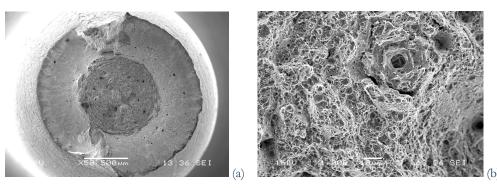
Figure 8: (a) Fracture surface for Maraging 250 specimen peak-aged at 535°C and (b) X1000 magnification for test in air.

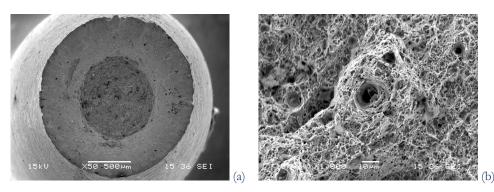
Figure 9: (a) Fracture surface for Maraging 250 specimen peak-aged at 535°C and (b) X1000 magnification for test in 3.5% NaCl aqueous solution with galvanic coupling.
